## PHOTO REPORT

## INSTALLING OF Ø400mm STEEL PIPE USING GRUNDORAM, GIGANT, PIPE PUSHING METHOD

- Client** : Brunei Shell Petroleum  
(Zainal H.M. Daud Sdn Bhd)
- Country** : Brunei, Seria (F13 – G13)
- Equipment Used** : GRUNDORAM type Gigant Hammer  
Fitted with upsized Ram Cone
- Ramming Distance** : 32m
- Pipe installed** : Ø400mm Steel Pipe
- Ground Condition** : Sandy with High Water Table
- Ramming Commencement Date** : 16<sup>th</sup> February 2006
- Ramming Completion Date** : 17<sup>th</sup> February 2006

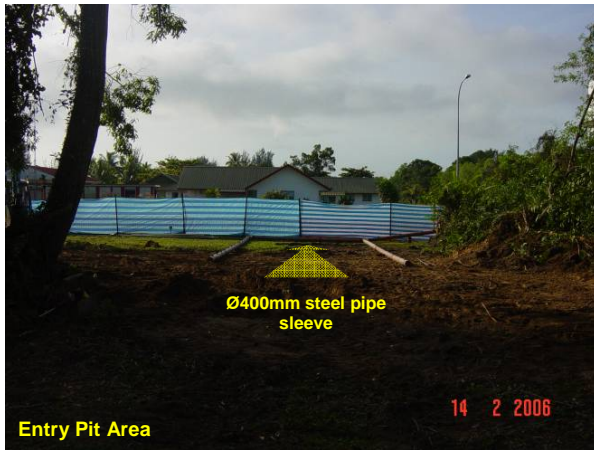
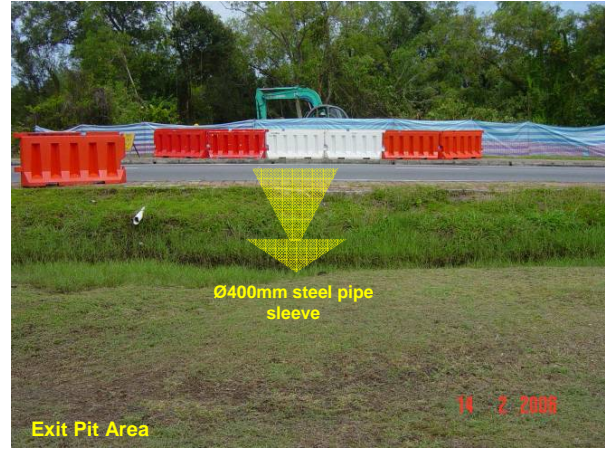
**Photo 1 & 2:** Installation of a Ø400mm steel pipe sleeve under a busy road (Jalan Tengah) in Brunei, Seria covering a distance of 32m.

Trenchless method was used as traffic is very busy because this is the only road connecting Seria to another town, Kuala Belait. In addition, BSP HQ is near the junction and traffic is very heavy during peak hours. There is also a fire station nearby and there is no alternative route for the fire station to use.

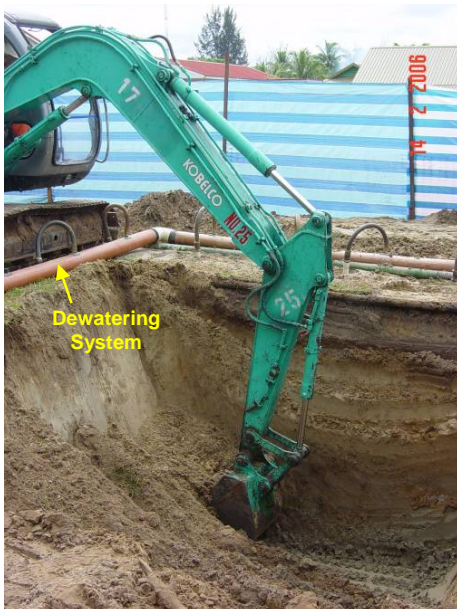
**Photo 3:** A view of the excavation being carried out.

The depth is 2.8m. Dewatering System had to be used as the soil condition in this area is very sandy with high water table.

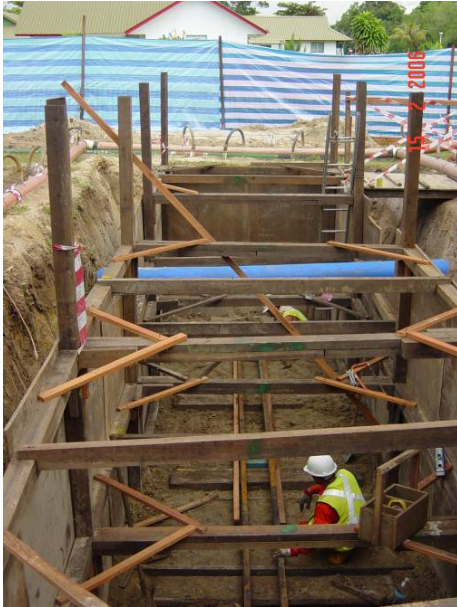
**Photo 4:** A view of the shoring completed at the Entry Pit. Workers were aligning the improvised rail to the Exit Pit.

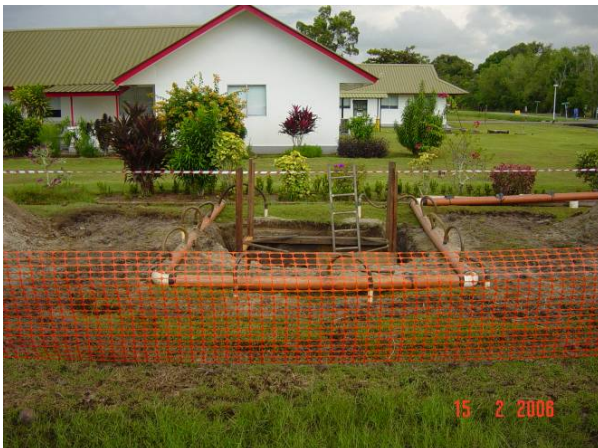
**Photo 5:** A view of the Exit Pit, just in front of the Fire Station.

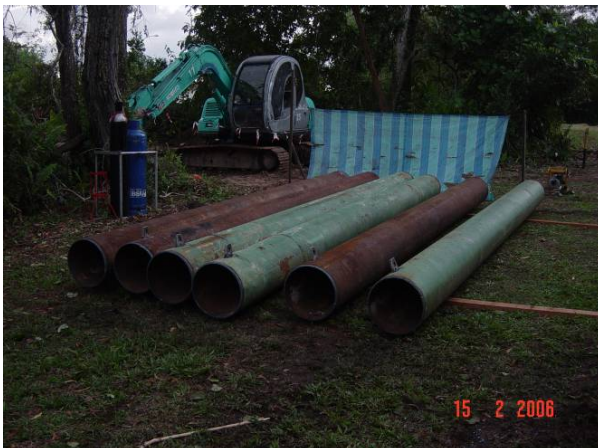
**Photo 6:** Six steel pipes, each about 6m, were used to cover the ramming distance of 32m.

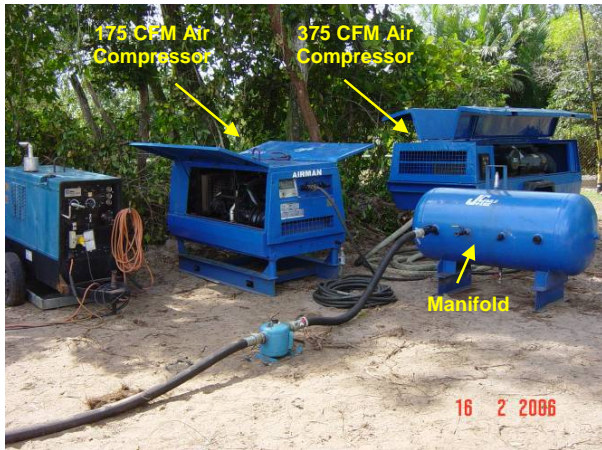
**Photo 7:** One 375CFM air compressor was combined with one 175CFM air compressor using a manifold to drive the Grundoram Gigant Hammer.

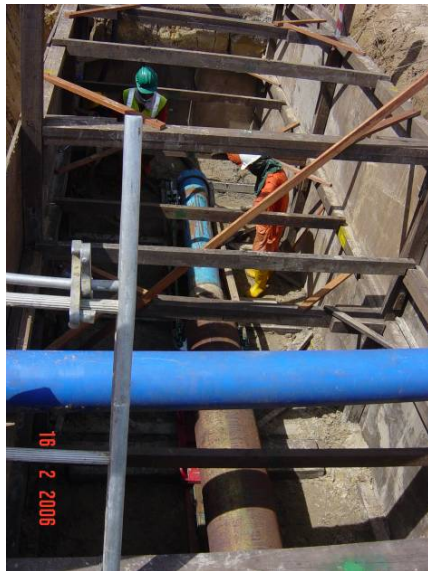
**Photo 8:** A view of the shoring at the Entry Pit with the Grundoram Gigant hammering in the Ø400mm steel pipe.

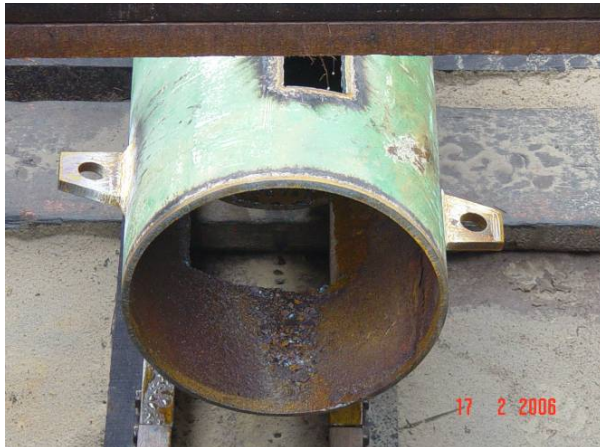
**Photo 9:** Two holes were cut, one above and one below, to allow water to wash out the spoils within the steel pipe while ramming.

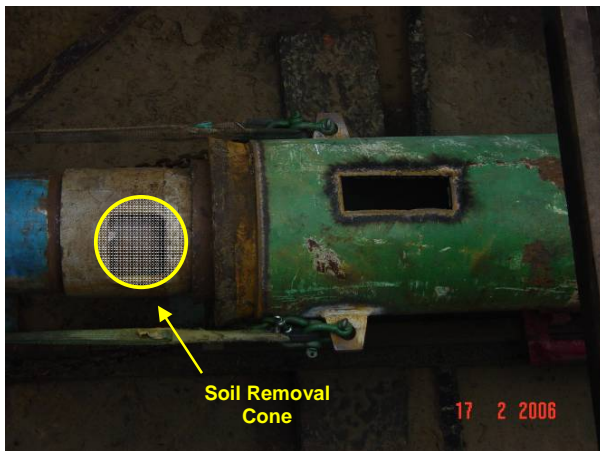
**Photo 10:** The hole in the soil removal cone is mostly blocked by the Grundoram Gigant. The spoils in the steel pipe cannot escape easily which caused the sand inside to be very compacted.

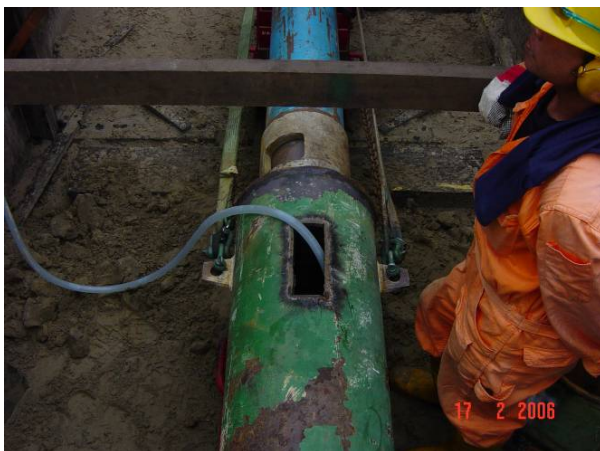
**Photo 11:** Water is inserted through the top hole on the steel pipe while ramming in the steel pipe.

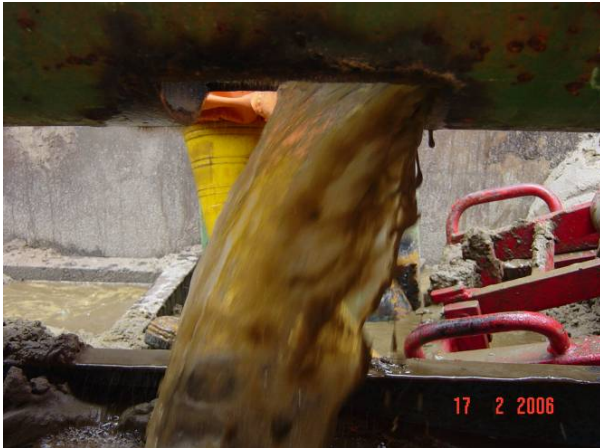
**Photo 12:** Water, together with sand in being washed out through the bottom hole on the steel pipe.

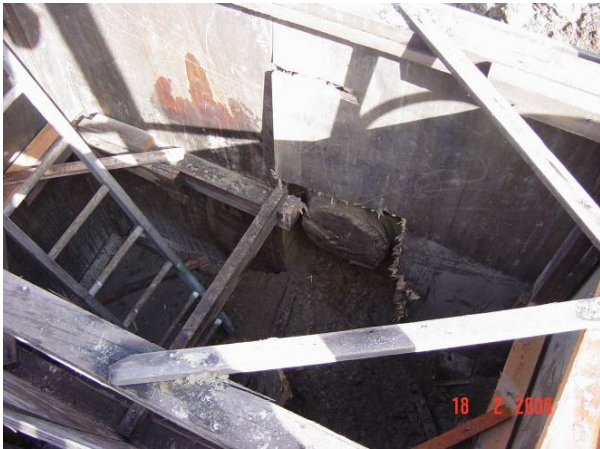
**Photo 13:** A view of the steel pipe emerging from the exit pit.

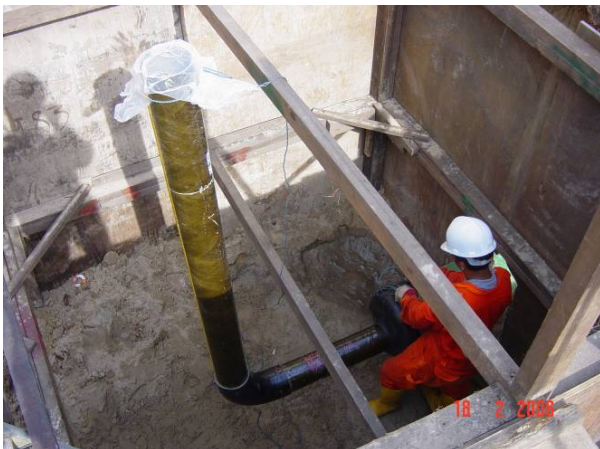
**Photo 14:** A view of the GRE pipe successfully inserted through the steel pipe.
